**DEPARTMENT OF TRANSPORTATION****DIVISION OF ENGINEERING SERVICES**

Contract #: 04-0120F4Cty: SF/ALA Rte: 80 PM: 13.2/13.9File #: 70.28**WELDING INSPECTION REPORT****Resident Engineer:**Pursell, Gary**Address:** 333 Burma Road**City:** Oakland, CA 94607**Report No:** WIR-005159**Date Inspected:** 07-Jan-2009**Project Name:** SAS Superstructure**OSM Arrival Time:** 830**Prime Contractor:** American Bridge/Fluor Enterprises, a JV**OSM Departure Time:** 2100**Contractor:** Japan Steel Works**Location:** Muroran, Japan**CWI Name:** Chung Kuan**CWI Present:** Yes No**Inspected CWI report:** Yes No N/A**Rod Oven in Use:** Yes No N/A**Electrode to specification:** Yes No N/A**Weld Procedures Followed:** Yes No N/A**Qualified Welders:** Yes No N/A**Verified Joint Fit-up:** Yes No N/A**Approved Drawings:** Yes No N/A**Approved WPS:** Yes No N/A**Delayed / Cancelled:** Yes No N/A**Bridge No:** 34-0006**Component:** Tower, Jacking and Deviation Saddles**Summary of Items Observed:****Steel Structure Welding Shop:**

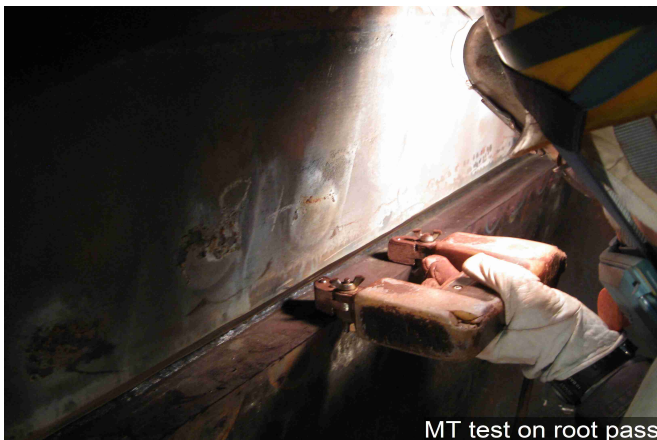
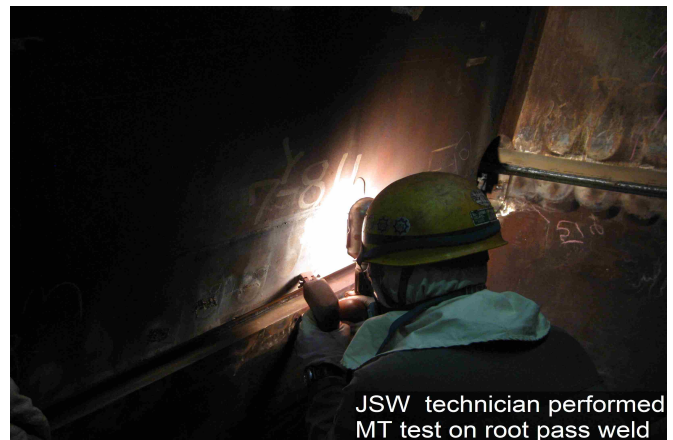
T1-2 Tower Saddle Casting: Caltrans QAI observed Nikko Inspection Service (NIS) NDT level II technician and an assistant performed Wet MT test on rib side of T1-2 tower saddle casting portion. The casting test surfaces have been machined and blasted prior MT test. The power source of MT testing used electromagnetic yoke with Alternating Current (AC) made by Magnaflux; model number CT-M1. The detection media is used wet red suspension particles mixed with water. A flaw indicator used to check the magnetic field direction and to ensure adequate field strength during MT testing. The test saddle appeared to be approximately 30% complete at this time and no relevant indications were found on the test surface. The wet MT testing will continue tomorrow.

W2E3 and W2W3 West Deviation Saddle casting: Caltrans QAI observed three JSW workers perform grinding process on exterior rough surface of rib sides of W2E3 and W2W3 west deviation saddles after arc-gouging. Grinding process is to remove all the exceed metal, oxide film and slag caused by gouging. The purpose for grinding is prepared for NDT test. Base on Caltrans observation, no discrepancies were noted.

T1-3 Tower Saddle Casting: The QAI observed Nikko Inspection Service (NIS) NDT technician perform dry MT testing on all the excavated metal surfaces of T1-2 tower saddle casting after grinding. The MT test used the yoke method. The yoke utilized appeared to be model UM 3BF, serial numbers 93-05. The magnetic field was verified with a field indicating gauge (pie gauge). Visible dry red magnetic particles were utilized and made by Magnotron, Japan. During MT test, no relevant indication on the surfaces were noted. The MT test will continue to tomorrow.

Based on Caltrans QA observation, the MT test operation appeared to be in general compliance with requirements of ASTM standard E709 and Caltrans contract documents.
